RIPPOWAM RIVER BASIN
STAMFORD CONNECTICUT

N. STAMFORD RESERVOIR DAM
CT. 00048

PHASE I INSPECTION REPORT
NATIONAL DAM INSPECTION PROGRAM

FEBRUARY 1979

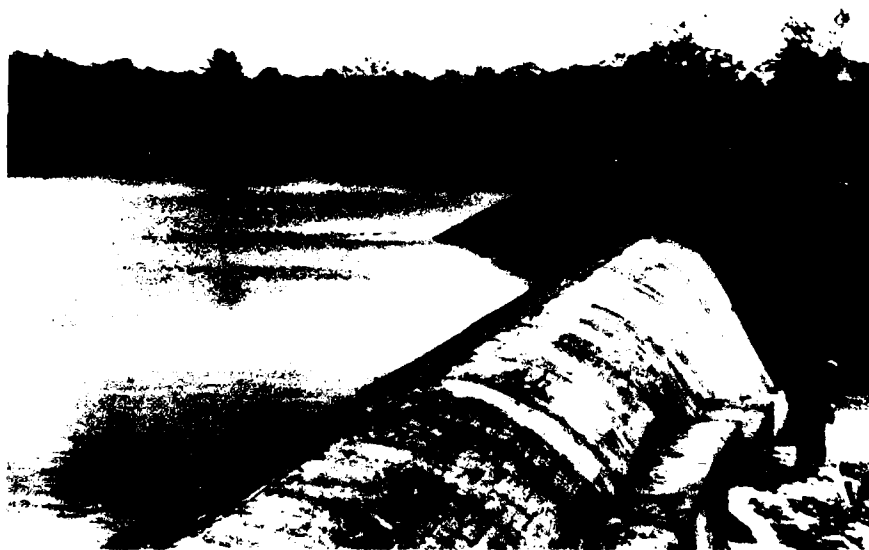
Overview from right abutment: new spillway foreground, gravity section left background.
